# CONTINENTAL GRAFIX USA INC TEST REPORT

ASTM D2859-2016 (REAPPROVED 2021) STANDARD TEST METHOD FOR IGNITION CHARACTERISTICS OF FINISHED TEXTILE FLOOR COVERING SYSTEMS ON FAT FLOOR

104795028MID-001

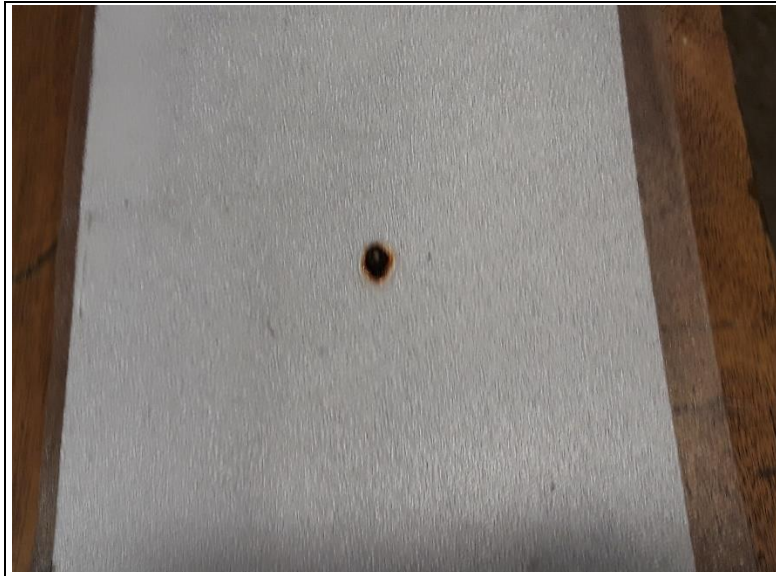
Photo No. 1  
Sample After Test

Sample melted, darkened to black and intumesced where the tablet was placed. There was no burn through or spread of flames from where the tablet was applied.
